PART VI - DAMAGE TO AIRCRAFT

PART VIII - CONCLUSIONS AND RECOMMENDATIONS

FAILURE ANALYSIS J65-116A ENGINE SERIAL 612332 FROM A-4C AIRCRAFT
BUNO 140567

VA 112 AAR 3-66A

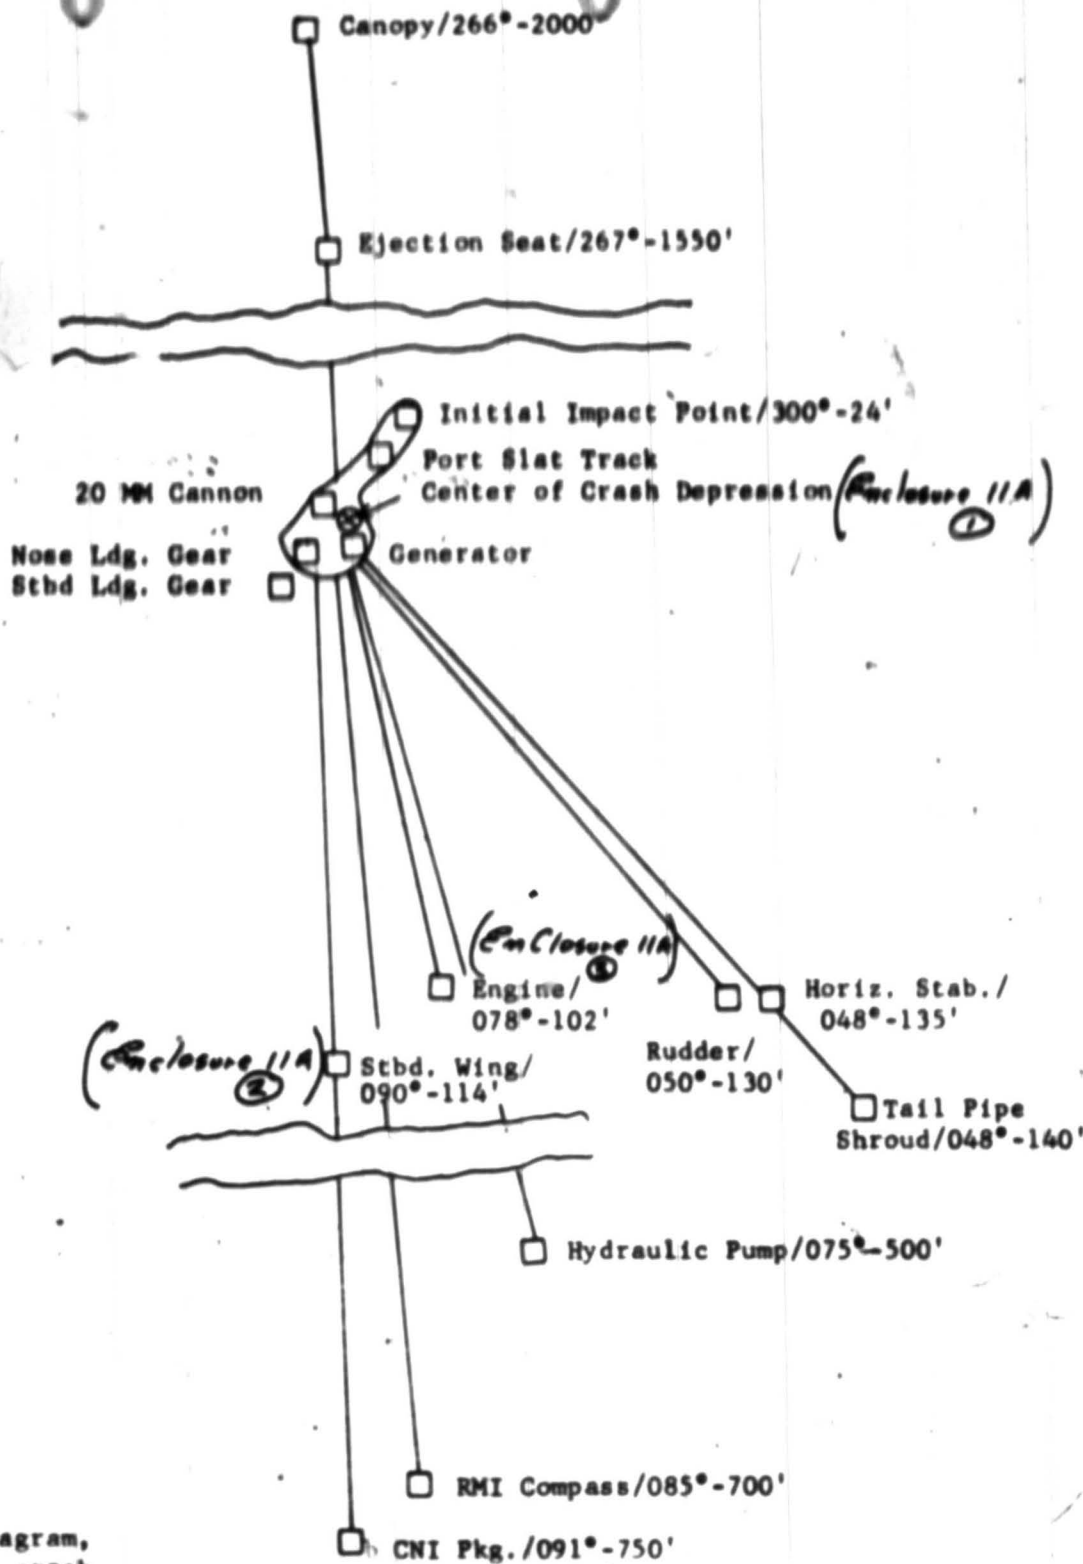
ENCLOSURE (7)

The aircraft contacted the ground in a 50-60° nose down, left wing low attitude. This was determined by statements of Major (b) (6) (enclosure (5)) and Mr. Frazier (enclosure (4)) and by the ground imprint of the aircraft. The heading at impact was 087°M at a speed of about 300 KTS. The left wing contacted the ground first leaving a shallow imprint of the leading edge. The nose section then partially cartwheeled into the ground due to the levering action of the port wing. Following nose impact, the engine tore loose from its mounts and ripped forward through the fuselage fuel cell (shredded sections of fuel cell, engine compressor blades, and the main generator were found in the main crash depression). The engine then contacted the ground and bounced out of the crash depression. It rotated at least 1/2 turn before alighting on its tail pipe 102' from the main crash depression (enclosures (8), (11A), (11B), and (11C)). During its 102' flight it scattered compressor rotor and stator blades an additional 500' and shed most of its accessory components. Shortly after the nose of the aircraft contacted the ground the starboard wing tore loose from the fuselage and flew 114' from the main crash depression (enclosure (11A)). The forward section of the fuselage was shredded on impact and remained in the main crash depression. The rear section of the fuselage, the rudder, the horizontal stabilizer, and the tail pipe shroud were scattered on a heading of 048°M from the main crash depression (enclosure (8)).

A-4C 148567 Wreckage Diagram,
oriented from center of crash
depression (all headings magnetic)

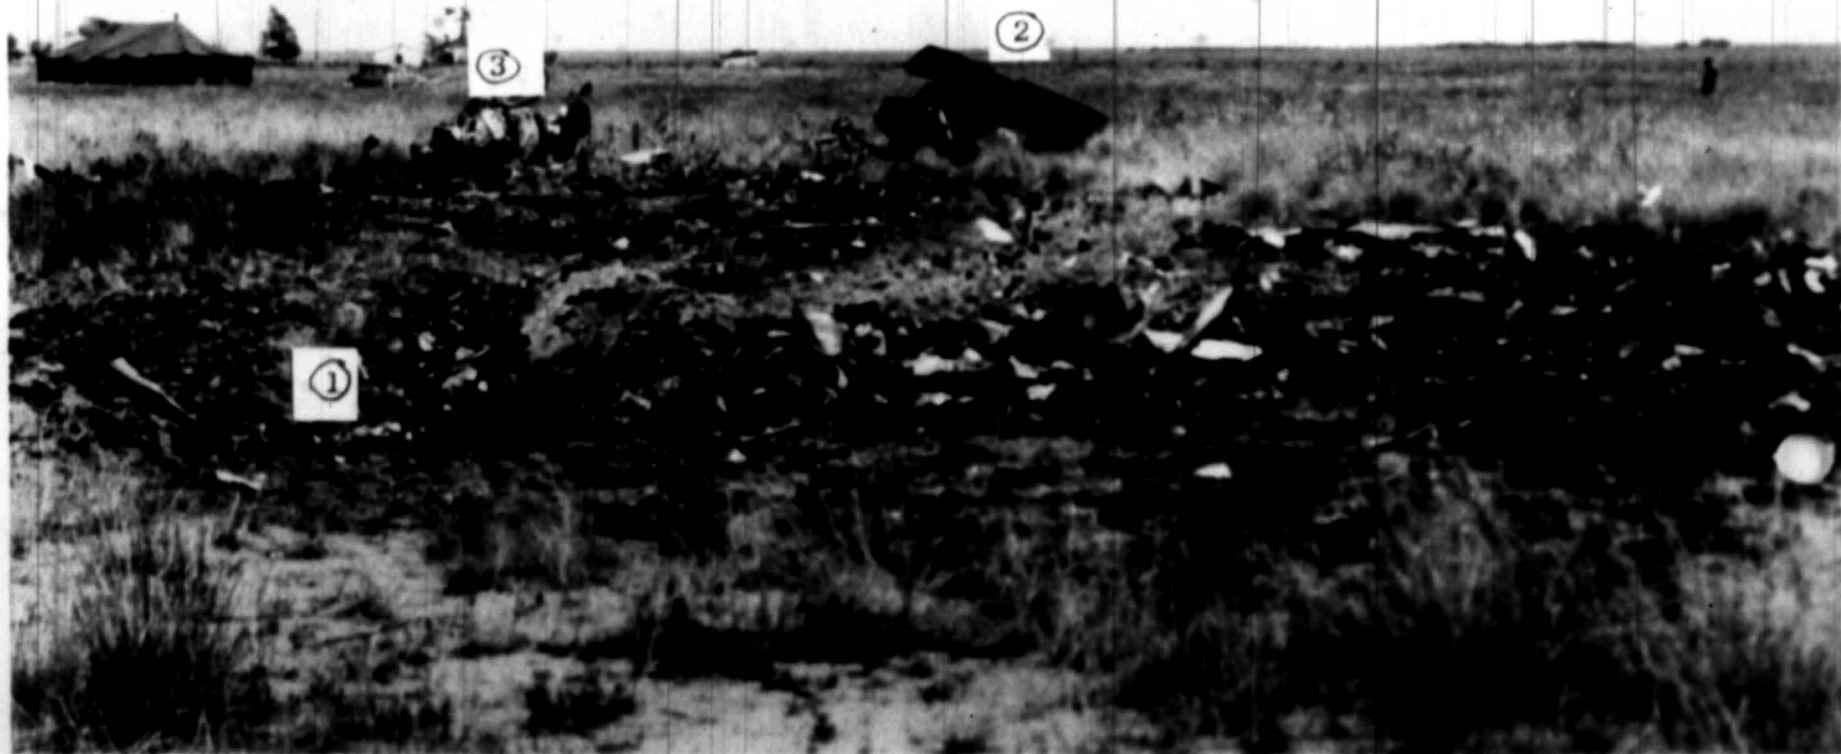
ENCLOSURE (11A)

VIEW OF CRASH SITE SHOWING: ① CENTER OF CRASH DEPRESSION ② STBD WING ③ 165 ENGINE. SEE ENCLOSURE (8) FOR HEADING AND DISTANCE INFORMATION.

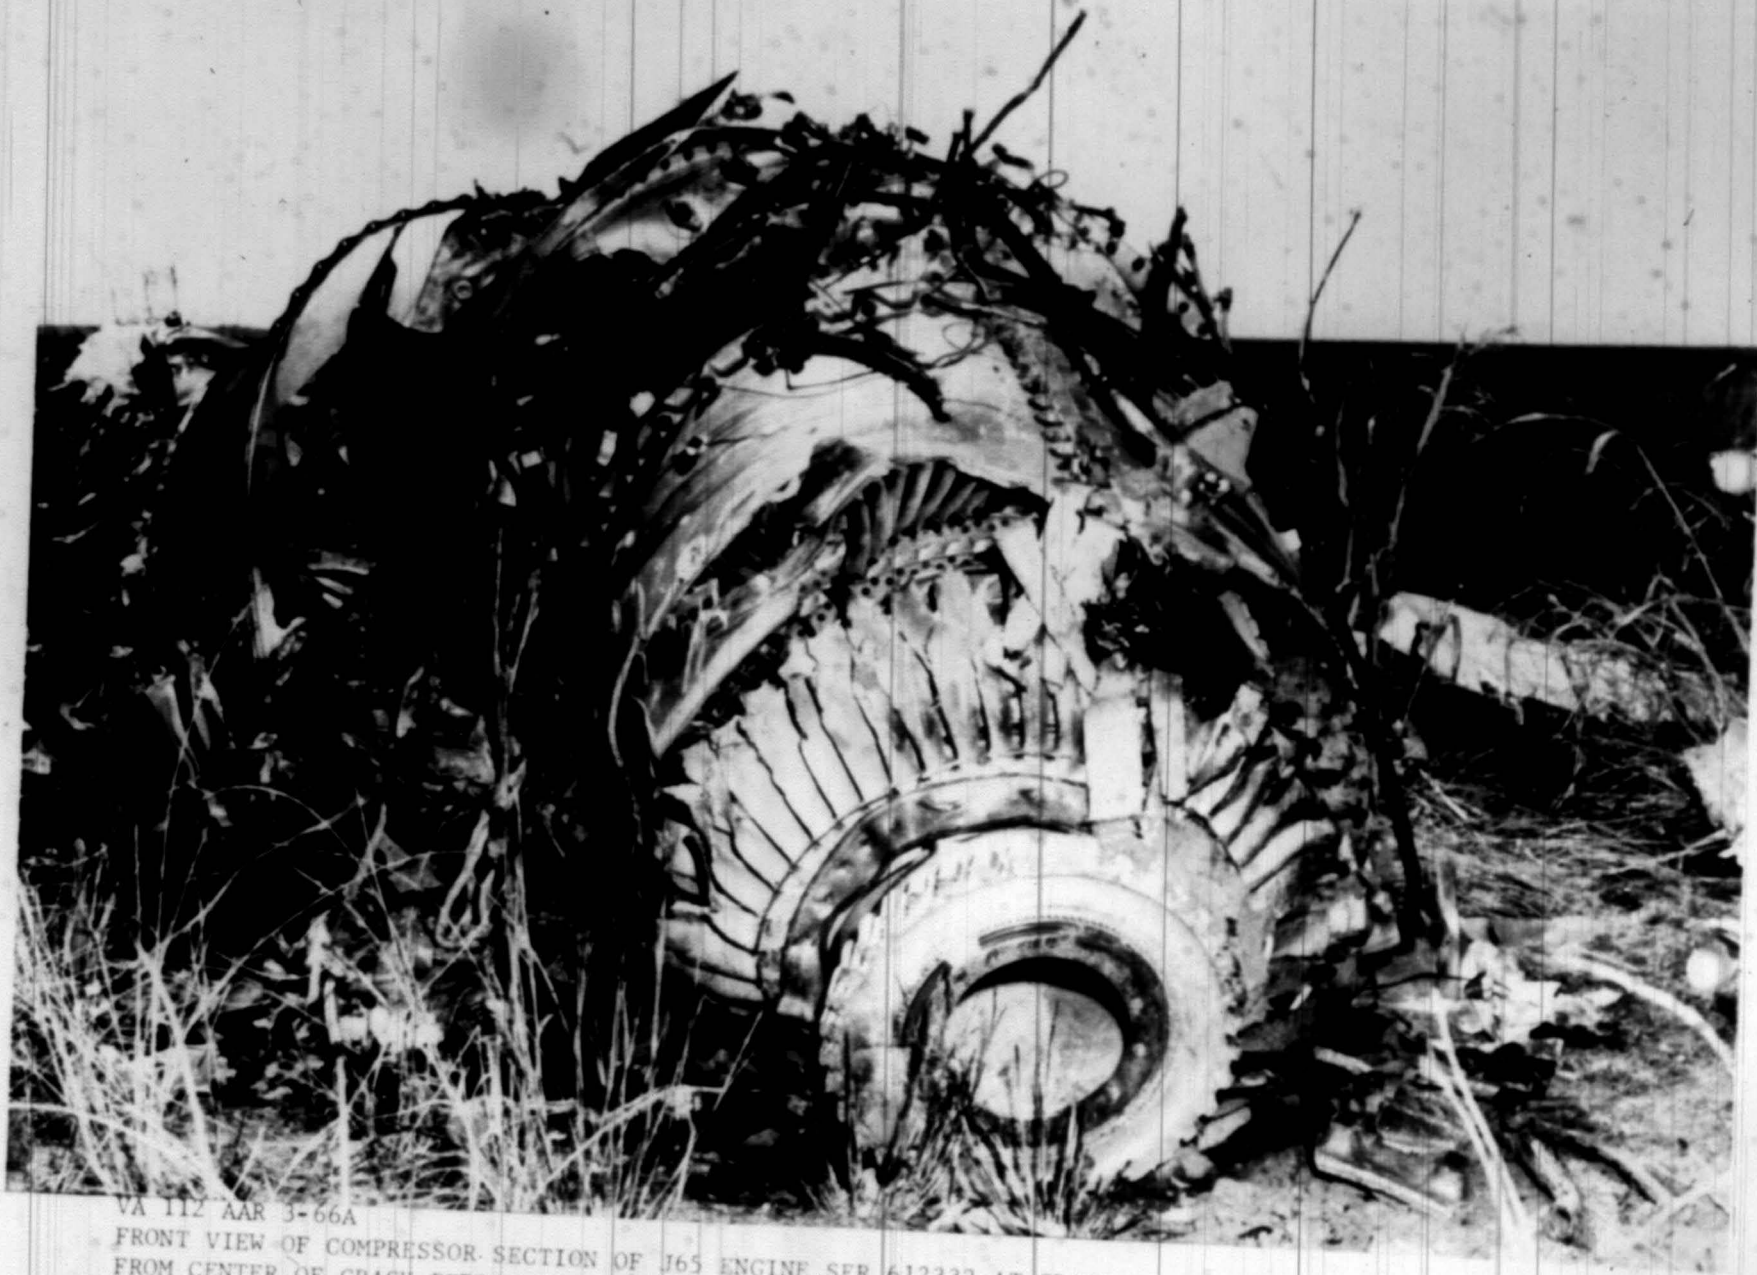
ENCLOSURE (11B)

COMPRESSOR ROTOR BLADES RECOVERED, TWENTY MISSING. ALL SECOND AND
THIRD STAGE COMPRESSOR ROTOR BLADES RECOVERED. ALL FOURTH THROUGH
SEVENTH STAGE COMPRESSOR ROTOR ALUMINUM BLADES WIPE OUT. EIGHTH
THROUGH THIRTEENTH ROTOR BLADES INTACT EXCEPT FOR ROTATIONAL DAMAGE.
ELEVEN COMPRESSOR ENTRANCE GUIDE VANES RECOVERED. ALL HAD ROTATIONAL
DAMAGE AT TRAILING EDGE. FIFTEEN FIRST STAGE COMPRESSOR STATOR
BLADES RECOVERED. MOST OF REMAINING STAGES OF STATOR BLADES WERE
RECOVERED. ALL COMPRESSOR BLADES HAD IN-FLIGHT ROTATIONAL DAMAGE.
ENGINE CONDITION INDICATED LITTLE OR ZERO RPM AT TIME OF IMPACT.

VA 112 AAR 3-66A
FRONT VIEW OF COMPRESSOR SECTION OF J65 ENGINE SER 612332 AT CRASH SITE. SEE ENCLOSURE (8) FOR LOCATION
FROM CENTER OF CRASH DEPRESSION.
SPECIAL HANDLING REQUIRED IN ACCORDANCE WITH PARA 66 OF OPNAVINST 3750.6E

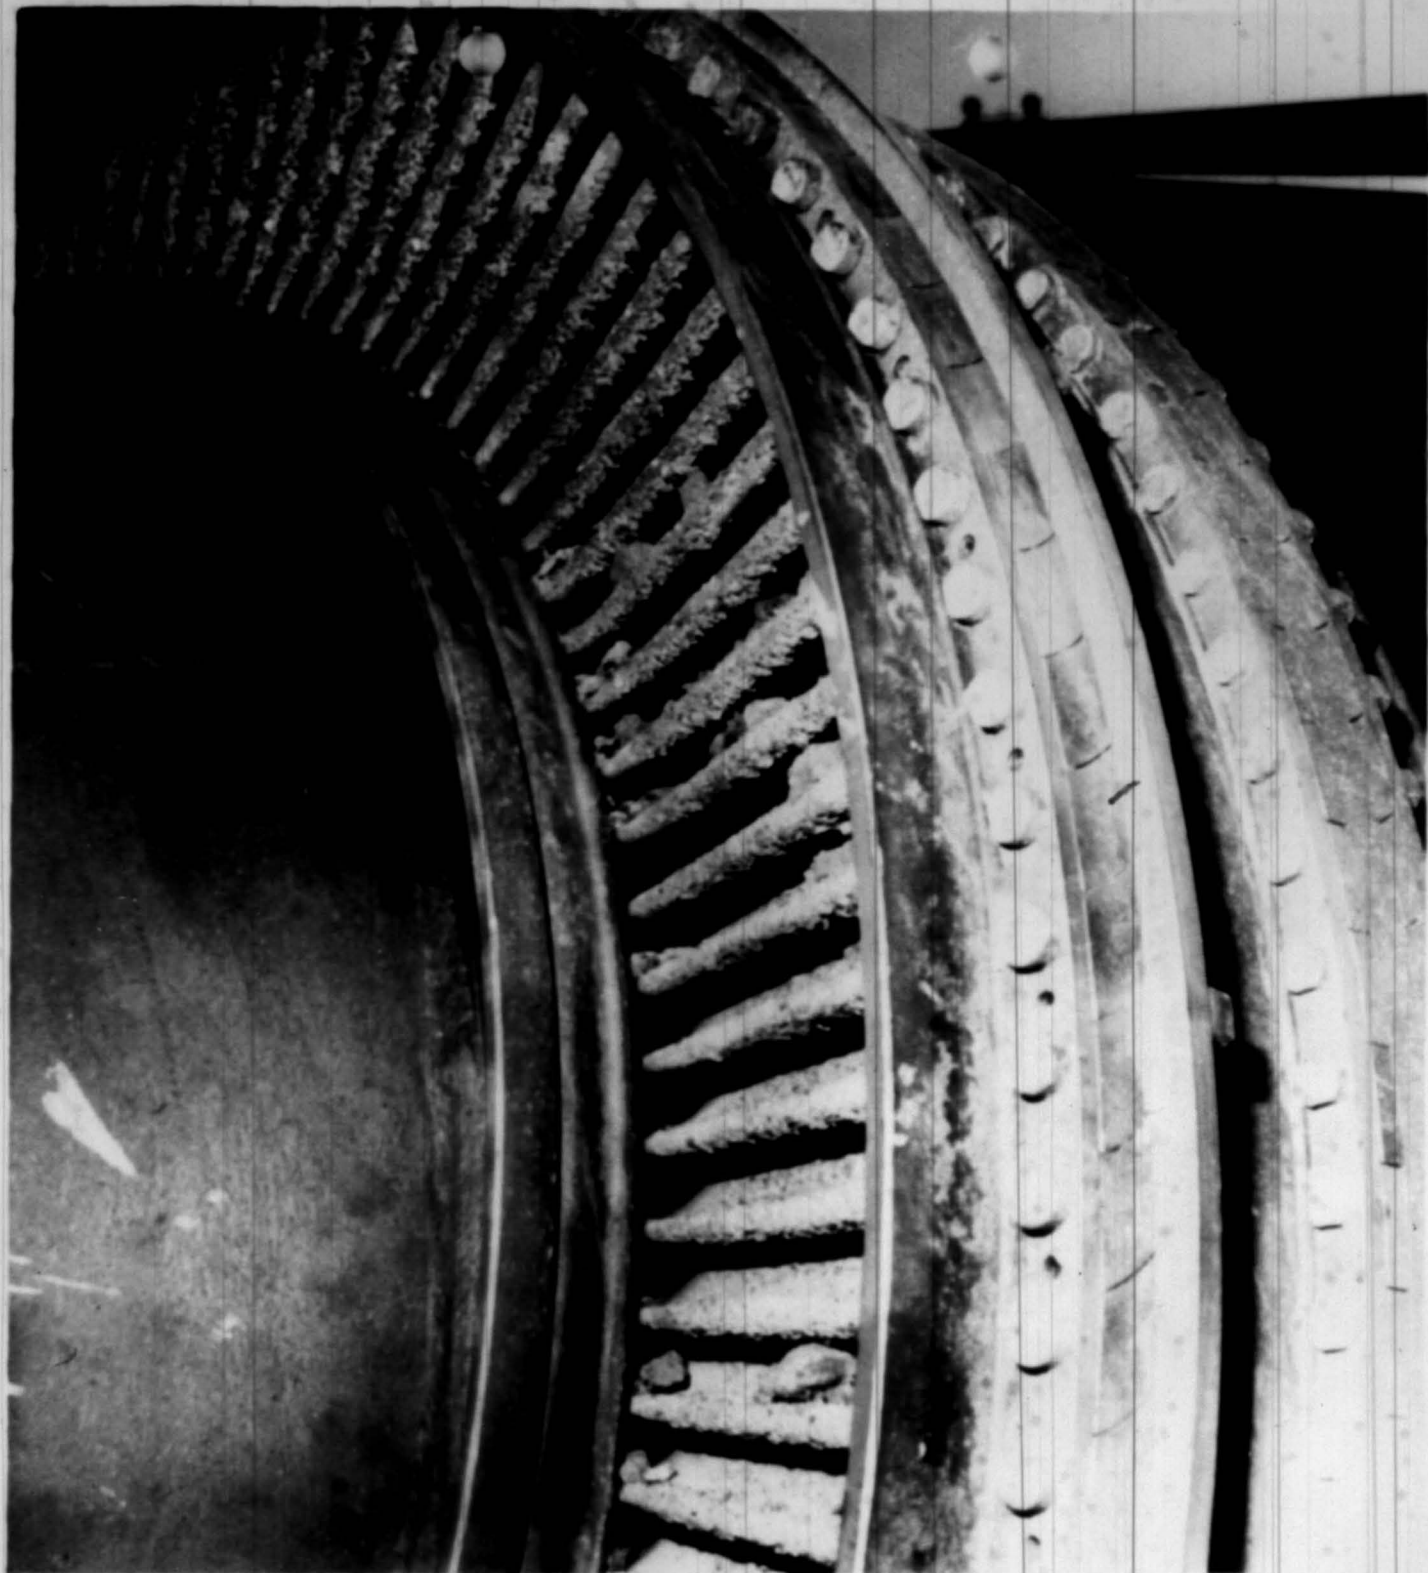
1. Heavy metallization was discovered on first stage turbine blades (enclosure (11D)).
2. Appearance of the engine and the pilot's statement gave indications of bearing failure.

3. TURBINE ROTOR AND STATOR BLADES WERE HEAVILY COATED WITH
ALUMINUM METALIZATION CAUSED FROM WIPEOUT OF ALUMINUM COMPRESSOR
BLADES IN FLIGHT. **WA FOREIGN OBJECT**

VA-112 AAR 3-66A
VIEW OF HEAVY METALIZATION ON FIRST STAGE TURBINE STATOR BLADES OF
J65 ENGINE SER 612332.

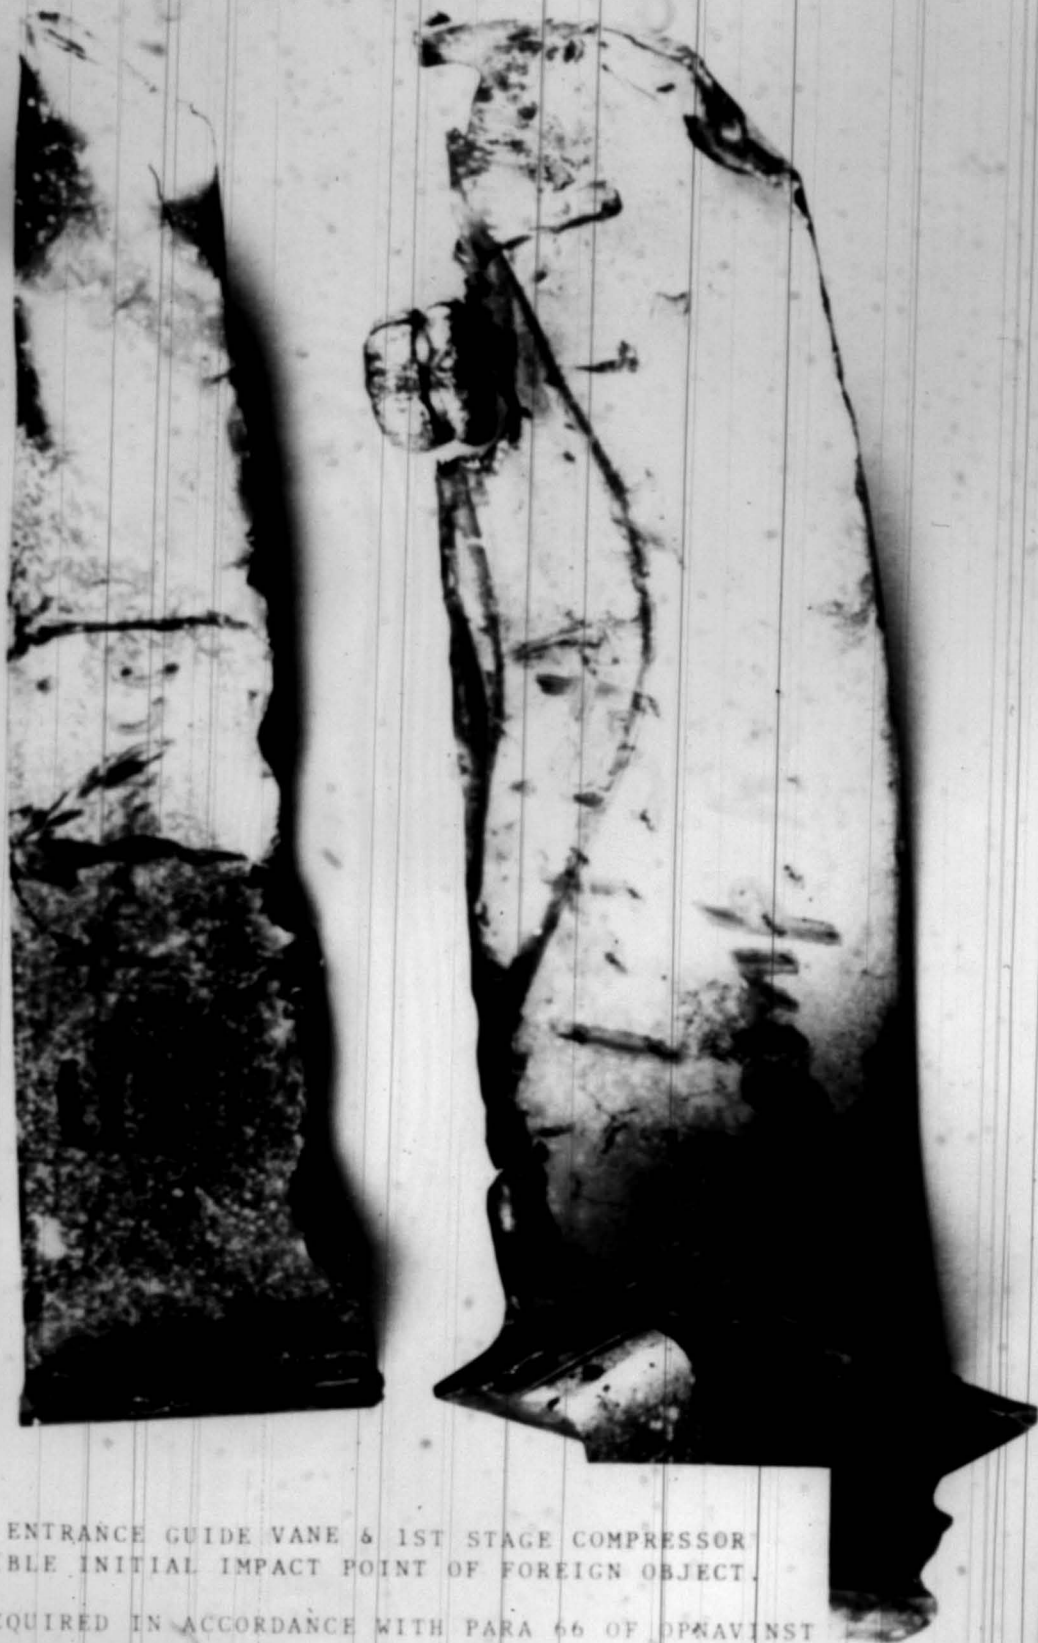
The next area investigated was Foreign Object Damage. This did not at first appear likely as the aft section of the compressor and the turbine section of the engine were in excellent condition. If there was FOD, it had not progressed as far as the turbine section, before the engine stopped rotating. If FOD was causal, was the Foreign Object integral to the aircraft, the engine, or caused by some external source? The pilot reported an explosion which felt like it came from under his left foot. The only moving part located in this position is the air conditioning turbine and even if it exploded, its location is low in relation to the port inlet duct of the engine. Ingestion from this source was considered unlikely. The air conditioning turbine was found in the main crash depression, was disassembled and found to be in good working order. All other engine accessories which could have been ingested into the engine were found and examined. The main generator, because of its location ahead of the engine and its susceptibility to icing was suspect. The case and armature were found at separate spots in the main crash depression but neither showed signs of inflight failure. There was no indication to the pilot of generator icing. The Board at this time returned to the crash site to screen-sift the dirt from the crash depression in hopes of finding some other evidence. A few more first stage compressor rotor and stator blades were recovered but nothing else. By this time the DIR Inspector had gone into the engine quite thoroughly. He analyzed the metallization on the turbine and determined it was aluminum from the 4th through 7th stage compressor rotor blades. He was also certain that FOD had caused the engine failure due to the appearance of the front stage compressor blades, but he was uncertain as to the source or type of FOD. In sifting out the dirt from the compressor section he found the foreign object shown in enclosure (11E, F, & G). His analysis was that the item was so peened that the damage to it could only have occurred inflight as a result of being ingested into the engine during hi-speed rotation. The origin of this item is still unresolved. It is peculiar in that its outer case is steel, it contains a threaded aluminum insert, and at one end a piece of brazed tubing was probably attached. A metallurgical examination is in process and a supplemental report will be submitted if the object is identified. The DIR Inspector stated that it is not integral to the engine and so far the Board, with Douglas Aircraft Company assistance, has been unable to determine its location on the A4 airframe. Remaining possibilities considered were that it was a piece of ground handling equipment or a special tool which was left in the intake duct and remained undetected during maintenance and preflight; that the object was drawn into the intake duct during taxi or takeoff; or that it was a piece of FOD which somehow was caught in the refueling store drogue basket during a ground maintenance period and was dislodged at the time the pilot commenced inflight refueling. If any of this theorizing is plausible, the item had to remain lodged against the inlet guide vanes for some indefinite time before it came loose and fell back into the

compressor face. The possibility exists that it became unbalanced when ice formed on it after the aircraft entered the precipitation area, or that the piece of brazed tubing which could have been attached to it was finally worn off by vibration or abrasion. The Board theorized that the hi-pitched squeal the pilot heard could have been the tubing being ground off initially until finally the entire steel section was pulled into the compressor section striking the first stage rotor blade as depicted in enclosure (11F). At this time several first stage blades failed and progressed into the third through seventh stages which vaporized due to hi rotational speed and the engine flamed out during the rapid deceleration. Compressor failure due to rotor shifing is a possibility that could not be determined. This type failure could have been induced without a bearing failure indication. Lacking evidence to the contrary, the Board felt that the illusion of an explosion under the cockpit was caused by induced vibratory airframe stress rather than a failure in this area. The yaw could have been the result of the loss of stability augmentation following power failure, or a shift in lateral location of the engine because of failure of the forward engine mount coincident with compressor failure.

VIEW OF J65 ENGINE ENTRANCE GUIDE VANE & 1ST STAGE COMPRESSOR
BLADE SHOWING POSSIBLE INITIAL IMPACT POINT OF FOREIGN OBJECT.
